Diagnostic Report:

Prepared for: Sample client

Property Address: 1234 Sample Dr., Suwanee, GA 30024 Inspected by: Tre Cain

Inspected on: 1/12/2024

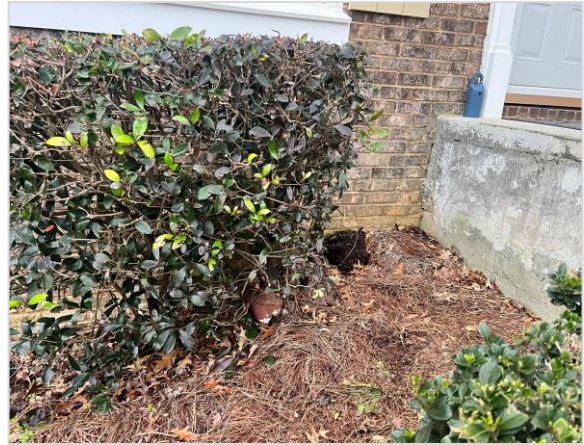
Plumbing Cleanout

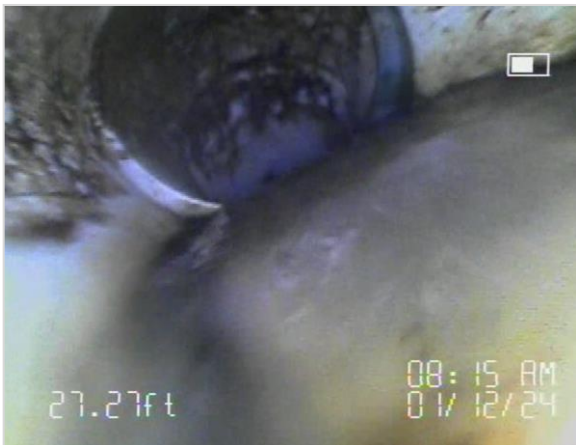
The inspected area of this sewage drain line was mostly unremarkable and without issue at the time of inspection. The drain line was clear of debris and had an adequate slope throughout.

General Condition of Line - Clear

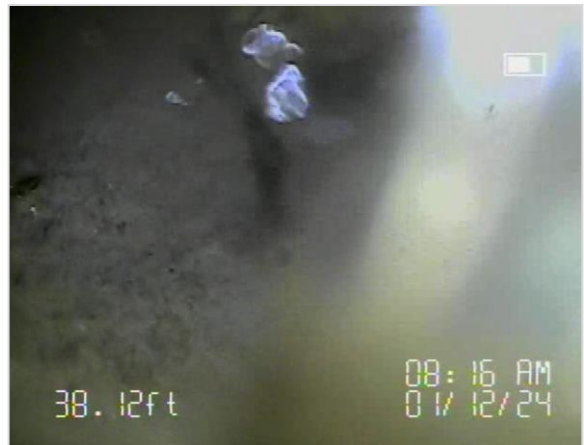
Limit of Reach - Sewer
