**Report:** Sample home inspection 2020

# **Confidential Inspection Report**

**123 Sample Rd**  
**Dacula, GA 30019**

**February 4, 2020**

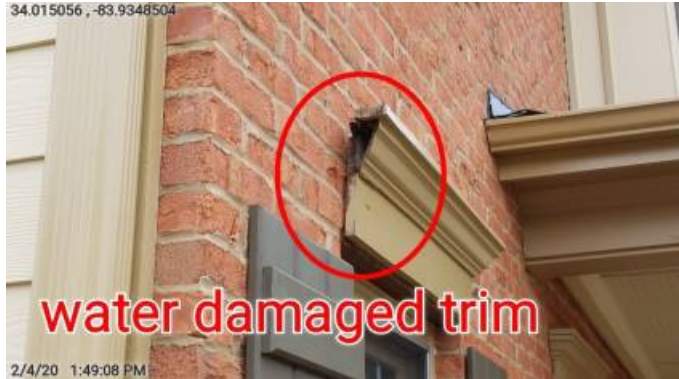
3.3 Flashing & Trim:                                     The trim on the home is constructed of wood materials.

The vertical trim on the corners of the home and other areas of the home where the vertical oriented trim meets the siding surface is missing and / or has deteriorated caulking / sealing. Recommend caulking all vertical trim on the home to the siding surface to prevent water penetration at the open seam.

Water damaged trim was noted on one or more locations around the home. Recommend a licensed contractor repair / replace all affected trim on the home to help prevent water penetration behind the siding system.

Recommend sealing the flashing around the AC lines to prevent water penetration around the AC lines.

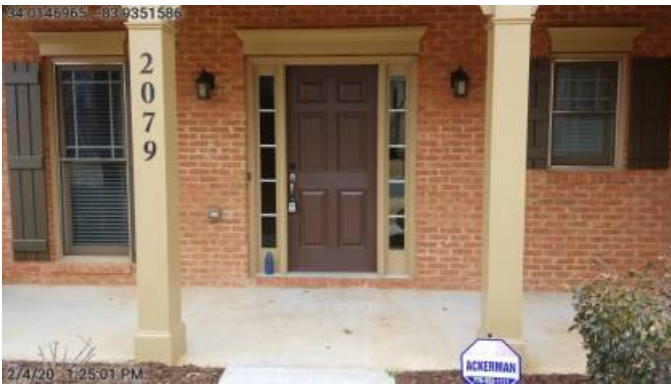
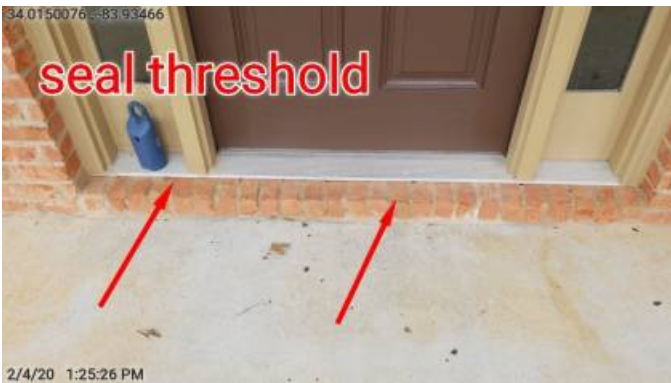
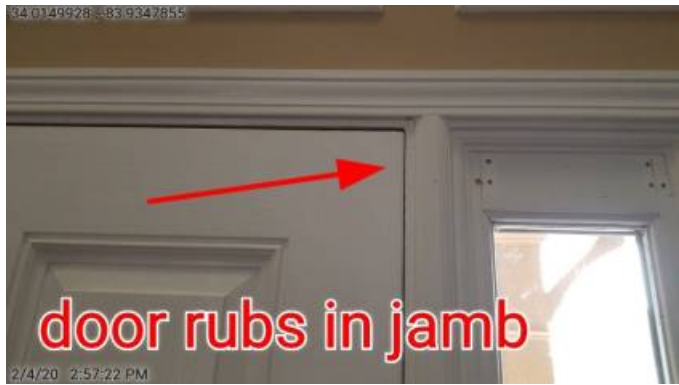
The threshold is not sealed at the base of the door. Seal / caulk the base of the front door to help prevent water penetration.

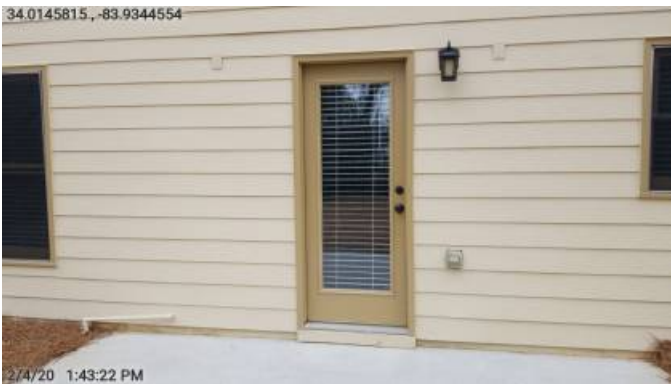
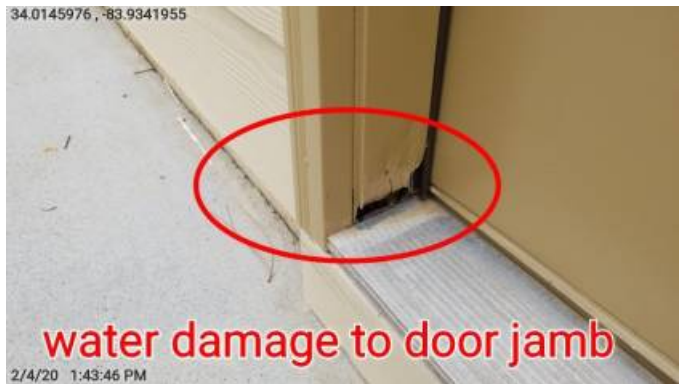
**Rear Entry Door:**

Significant water damage was noted at the lower portion of the doorframe. This may include the jamb and trim to either or both sides of the door as well as damage to the door itself.

The threshold is not sealed at the base of the door. Seal / caulk the base of the front door to help prevent water penetration.

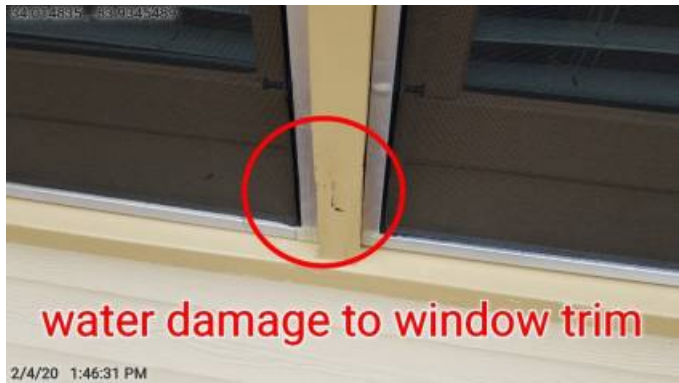
Water damage was noted on one or more window(s) around the home. Recommend a licensed contractor repair or replace all damaged sections of the windows and / or trim as necessary.

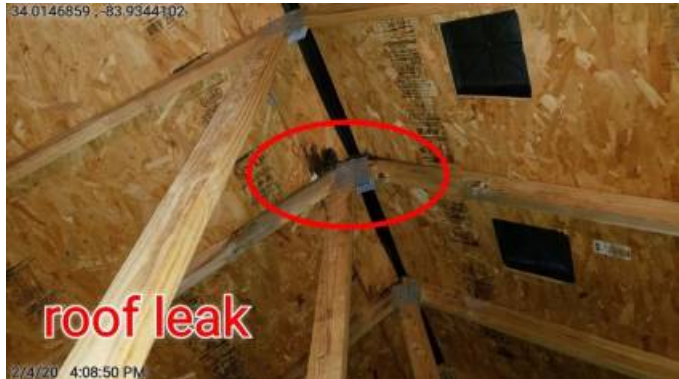
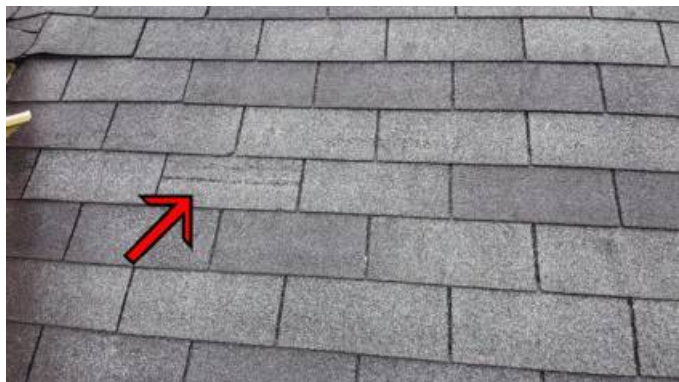
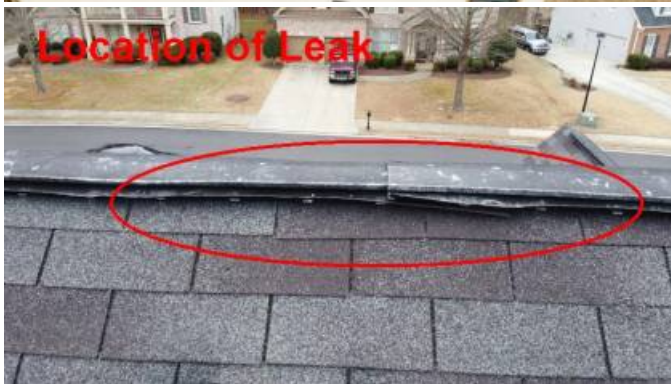
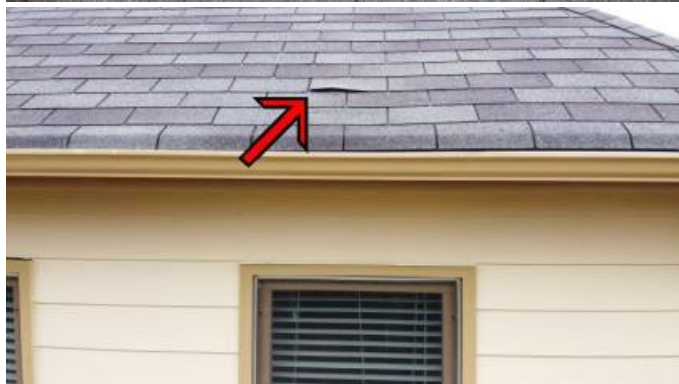
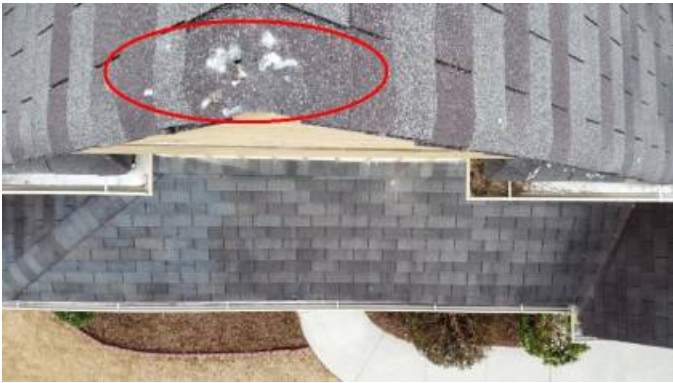
5.4 Roof Covering Condition:      OK   MM   RR   IS

An area of active leakage is suspected as evidenced by water staining below in the attic or the ceilings in the home. Recommend repairs by a licensed roofer.

The shingles at the gable ends of the roof ridges are torn. Recommend repairs / replacement of the affected shingles.

One or more shingles on the roof are damaged and or missing. Repairs by a licensed roofer will be necessary.

Cracking and clawing of shingles are the result of long term weathering and an advanced shingle age. Felts are showing through.

Roof is nearing the end of its normal life expectancy. Roof covering replacement is needed in the near future. A licensed roofing contractor should be called to make further evaluation and to provide cost estimates for roof covering replacement in the near future.

Several of the shingles are raised due to nails backing out of the sheathing. Recommend sinking all raised nails to ensure all shingles are flush with the roof.

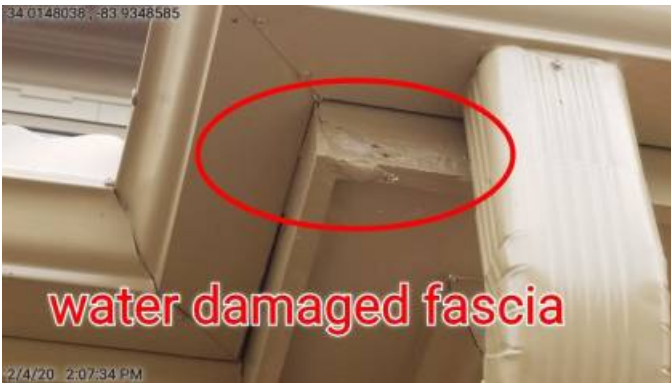
The fascia is water damaged at one or more of the corners of the home. This is typically the result of a leak at the gutters on the 90 degree seams. Recommend repairs to the wood fascia once the gutter leaks are addressed.

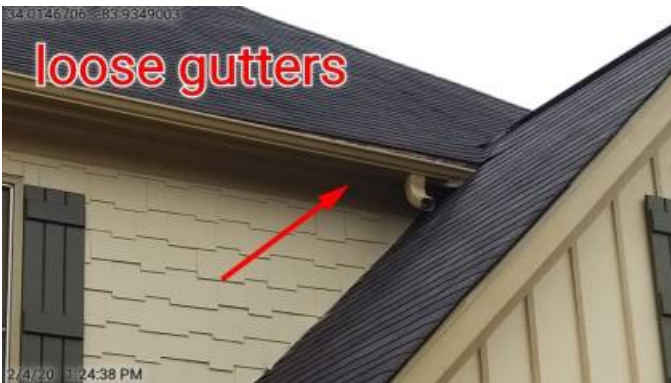
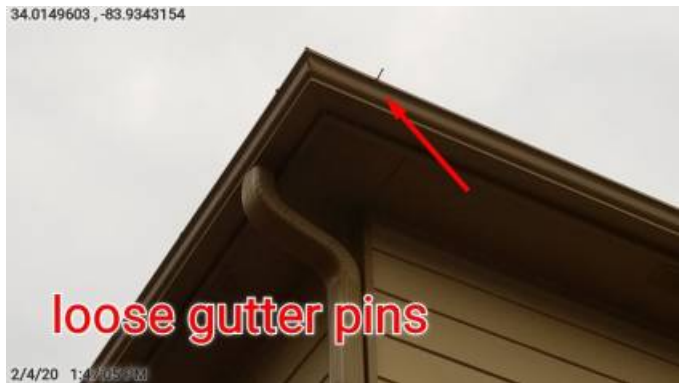
5.9 Type & Condition:

7. Extend downspouts to route rainwater away from the building. Gutters are discharging water near the foundation. Extensions should extend a minimum of 4 to 6 feet from the homes foundation.

Gutters are loose and pulling away from the fascia at one or more locations around the home. Recommend securing the gutters to the fascia to promote water flow to the downspouts.

There are one or more gutter pins loose around the perimeter of the gutters on the home. This may lead to misaligned gutter and gutter damage. Recommend securing all gutter pins to help ensure a proper slope on the gutters.

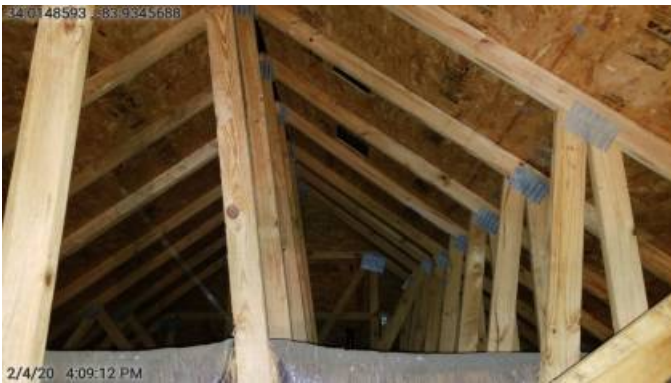
The builder did not install ply clips during installation, which may result in sagging at the joints of the sheeting.

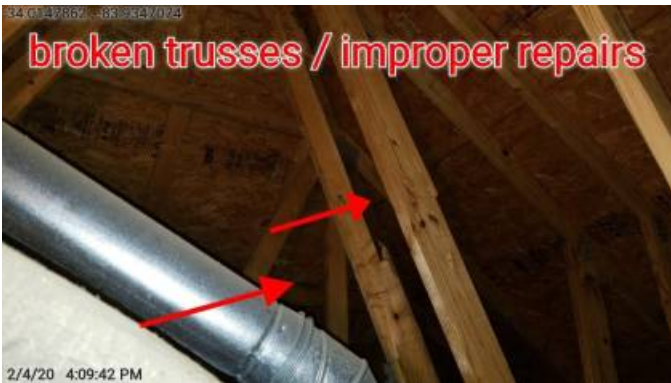
5.12 Structure Condition:     There is one or more broken trusses throughout the attic space. Recommend repairs of the broken trusses by a licensed structural contractor.

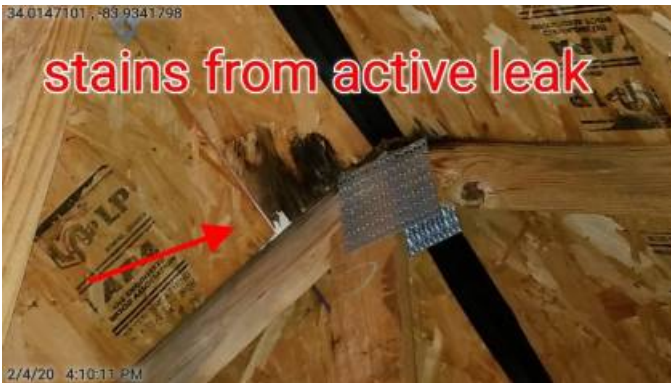
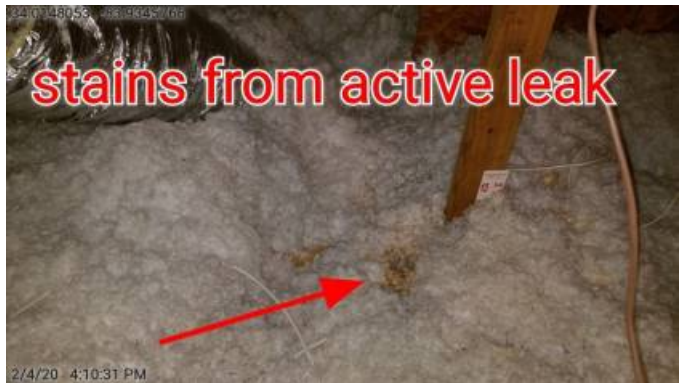
5.13 Moisture: OK  MM  RR  IS

Wet water staining was noted on the sheathing. Recommend further evaluation and repairs by a licensed roofer to repair the roof leak and help prevent further water penetration.

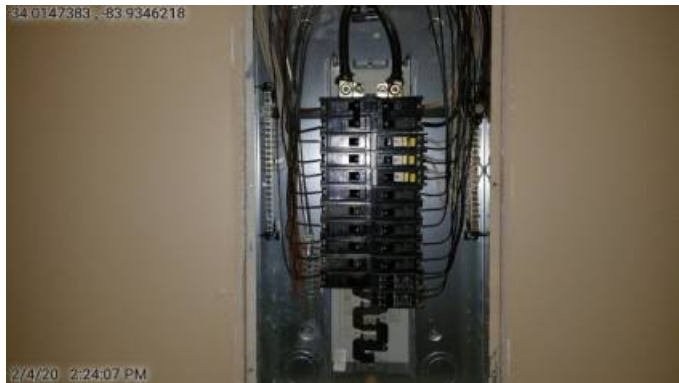
6.6 Main Panel Observations:      OK   MM   RR   IS  
            One or more of the Arc-Fault breakers in the panel did not trip when tested. Recommend a licensed electrician replace the defective Arc-Fault breakers.

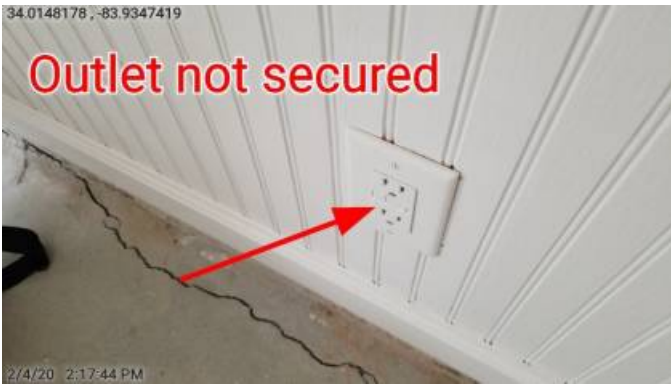
One or more outlets were loose in the room. Secure all outlets to the junction box as a safety concern.

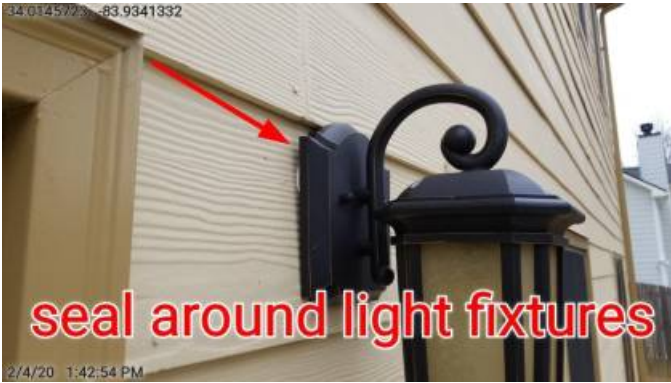
The exterior light fixtures are not caulked / sealed to the home allowing water to run behind the fixture and siding. Recommend caulking around the light fixtures to prevent water penetration.

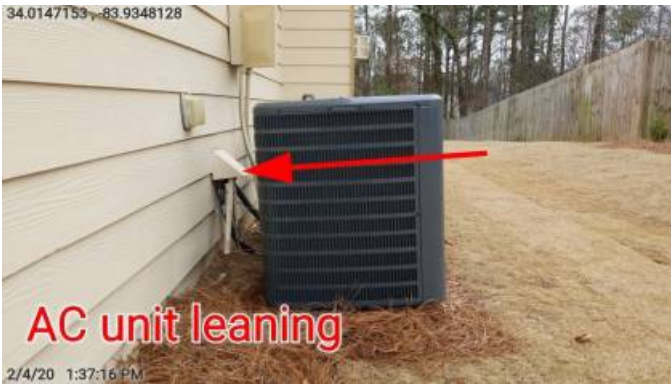
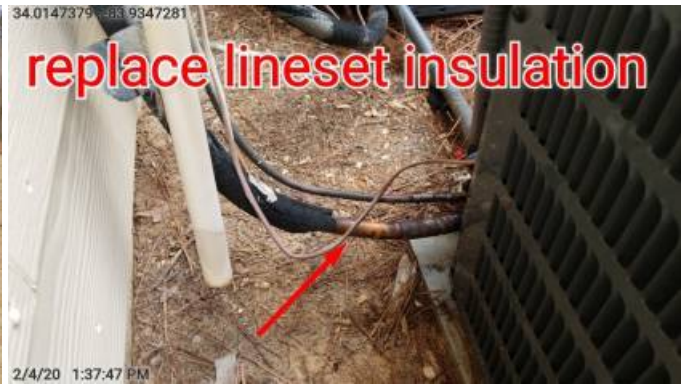
The unit is leaning due to erosion around the base of the AC pad. Recommend leveling the unit for efficient operation.

The insulation on the exterior refrigerant lines is deteriorating. Recommend replacing the insulation.

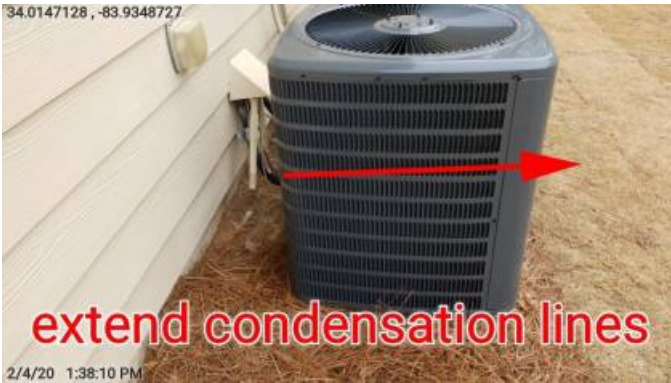
7.6 Condensate Line:      OK   MM   RR   IS

The condensation line terminates behind the AC unit and / or directly next to the foundation. This may cause erosion in the area and affect the foundation over time as well as cause the AC unit to lean. Recommend extending the condensation line a minimum of 4 - 6 feet from the foundation to prevent further erosion / damage.

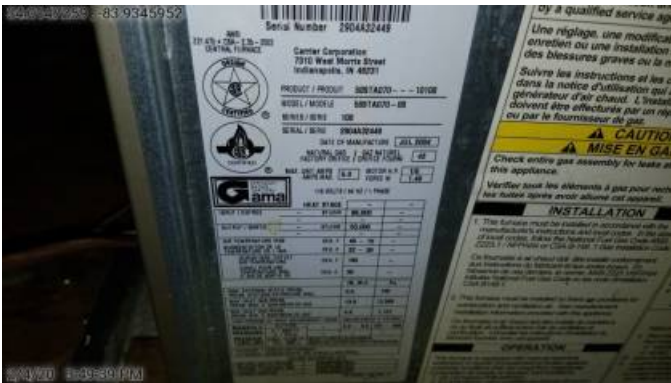
Manufacture Date- 2004.
- The typical service life for a forced air natural gas furnace / heat pump is 18 - 20 years. The heating system is approaching the design life. The system is more likely to fail the nearer it approaches design life. Recommend general maintenance and service checkups going forward to extend the life of the existing heating system.

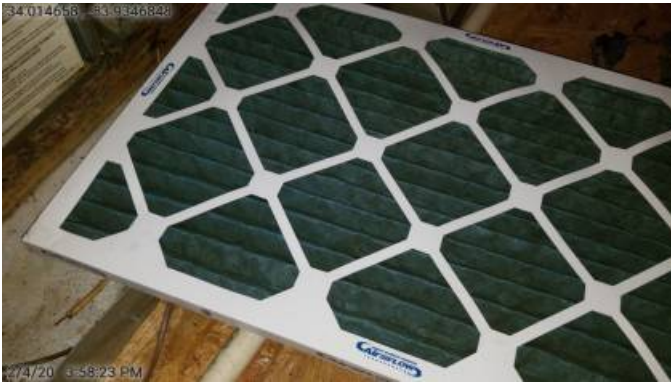
The filter is in need of cleaning or replacement. Replacing or cleaning filters every 30 to 45 days or per manufacturers recommendation is advised.

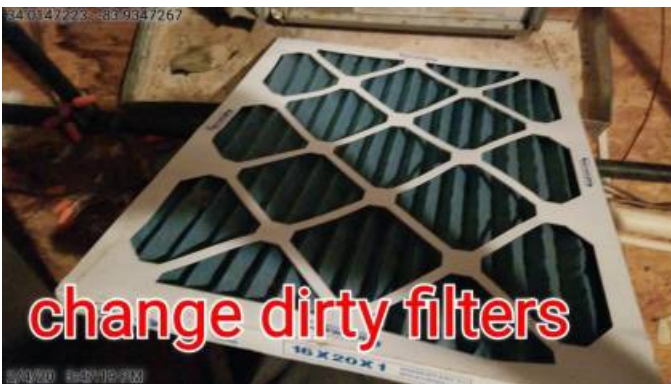
The filter is in need of cleaning or replacement. Replacing or cleaning filters every 30 to 45 days or per manufacturers recommendation is advised.

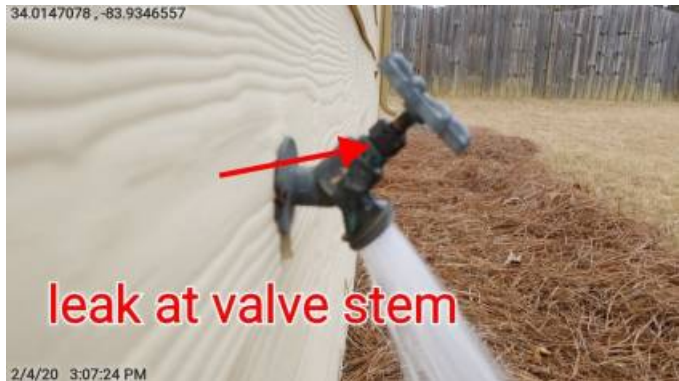
There are gaps noted around one or more of the water faucets around the exterior of the home. Recommend securing and sealing the faucet to the wall to prevent water penetration behind the siding system.

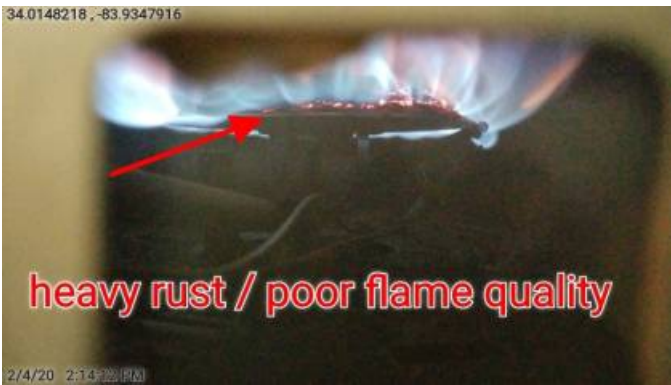
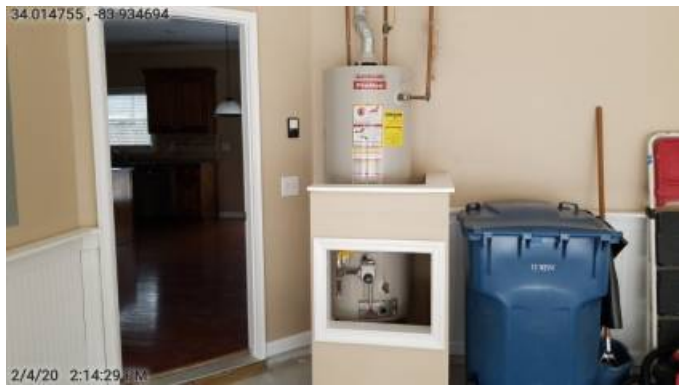
Poor flame quality noted. There is a significant amount of orange mixed with the blue flame. This may indicate rust on the burners or that the water heater is not burning efficiently. Recommend a licensed plumber service the system.

Heavy rust was noted inside the burner compartment. Recommend servicing / cleaning the burner compartment for a more efficient burn and operation.

Due to the age and / or general condition, replacement should be considered in the very near future.

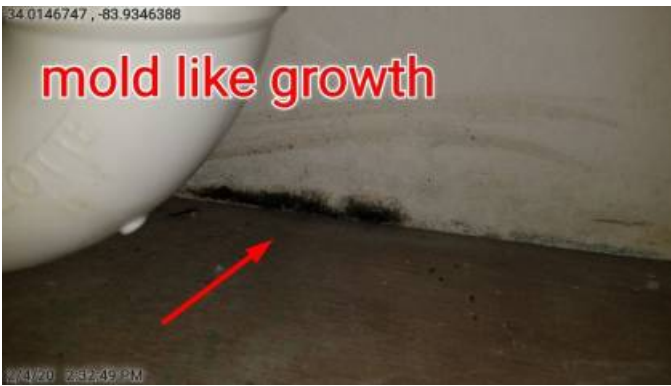
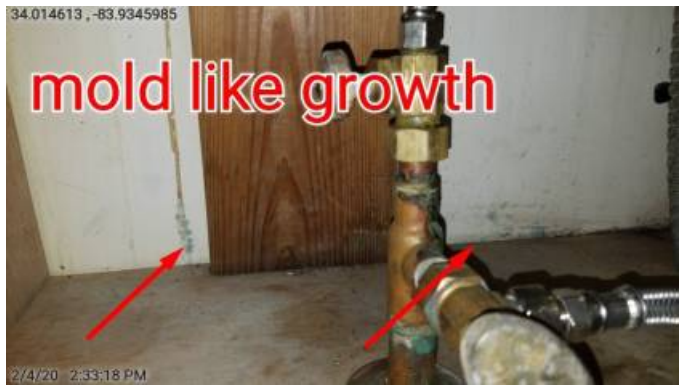
Mold like growth was noted below the sink as a result of a previous or active leak. Recommend removal of all mold and affected materials after ensuring there are no more sources of moisture or leakage.

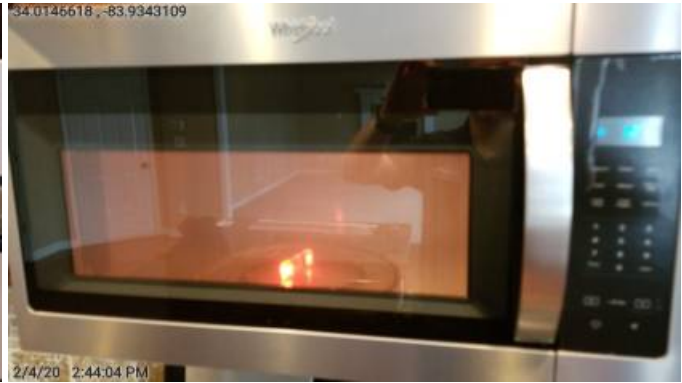
The microwave was installed too close to the stove top. There should be 18 inches above the stove top to the bottom of the microwave. This is a safety hazard.

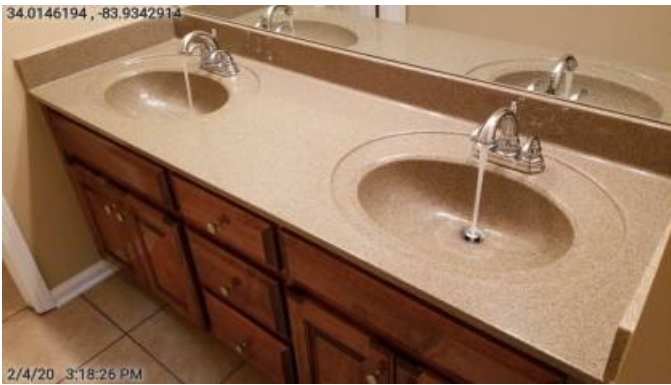
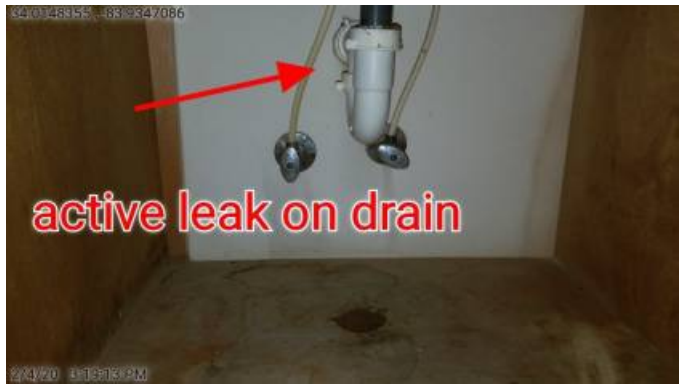
<i>10.2 Second Floor Bath:</i>	<input type="checkbox"/>	<input type="checkbox"/>	<input checked="" type="checkbox"/>	<input type="checkbox"/>
--------------------------------	--------------------------	--------------------------	-------------------------------------	--------------------------

Leakage was noted at the right side drain. Recommend immediate repairs by a licensed plumber.

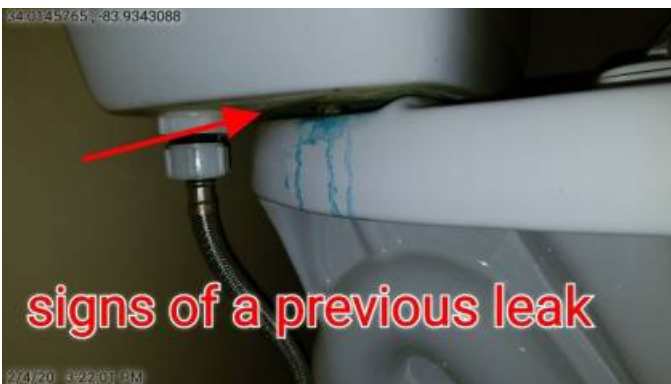
Water stains below the toilet tank would indicate a previous leak at the toilet. All stains and flooring around the toilet were dry at the time of the inspection. Monitor condition.

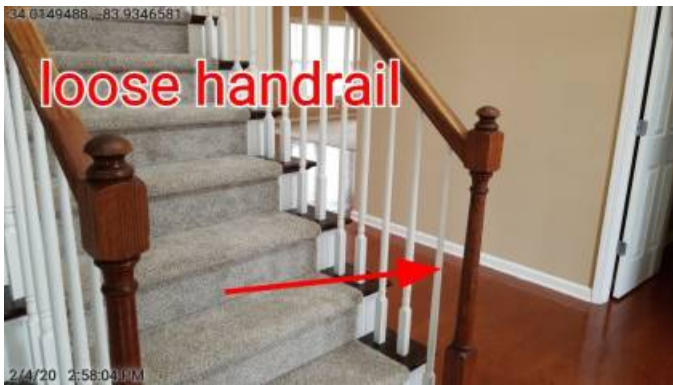
OK	MM	RR	IS	
11.1 Condition:	<input type="checkbox"/>	<input type="checkbox"/>	<input checked="" type="checkbox"/>	<input type="checkbox"/>	The handrail to the second floor is loose. This poses a safety hazard. Secure the handrail for safety purposes.

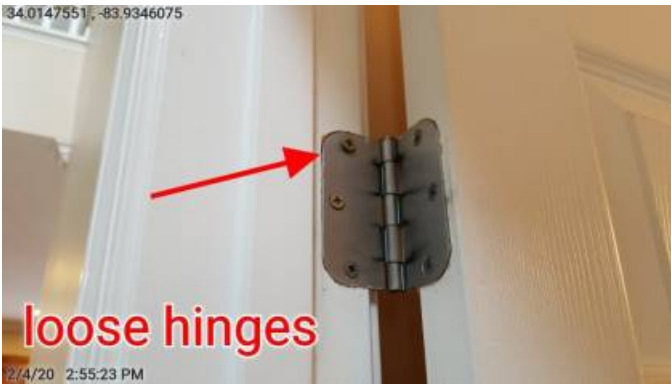
Door hardware needs adjustment or repair as at least one of the door hinges needs repair or replacement.

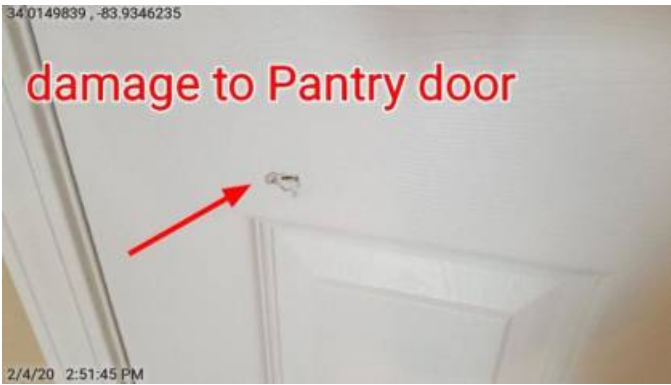
11.10 *Family Room:*

The pantry door skin is punctured or broken and is no longer performing as intended.

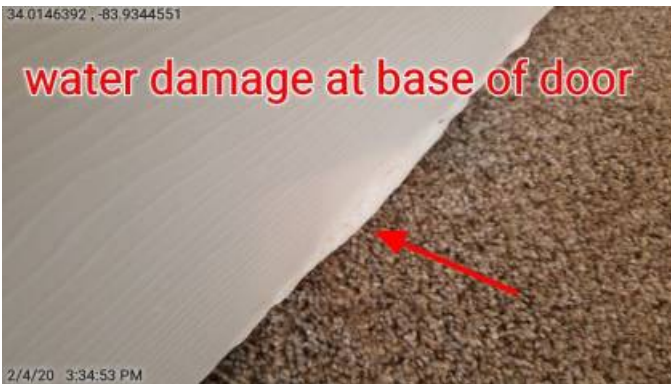
11.11 Master Bedroom:      OK   MM   RR   IS

There appears to be some form of water damage at the base of the door to the master bedroom. Recommend inquiring with the current homeowners as to any previous water problems in the area and monitor condition.

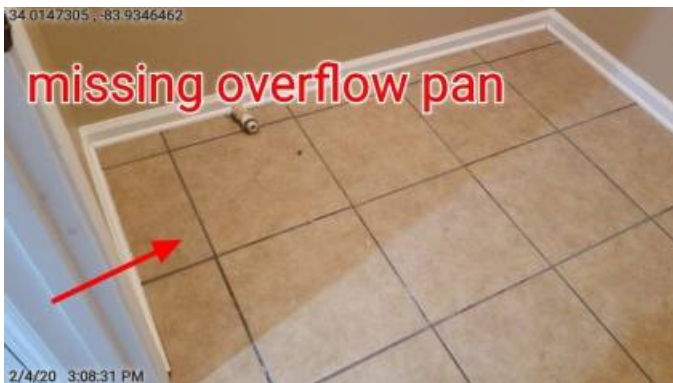
12.5 Over Flow Pan     The overflow pan below the washing machine is missing. Recommend installing an overflow pan as a safety precaution.

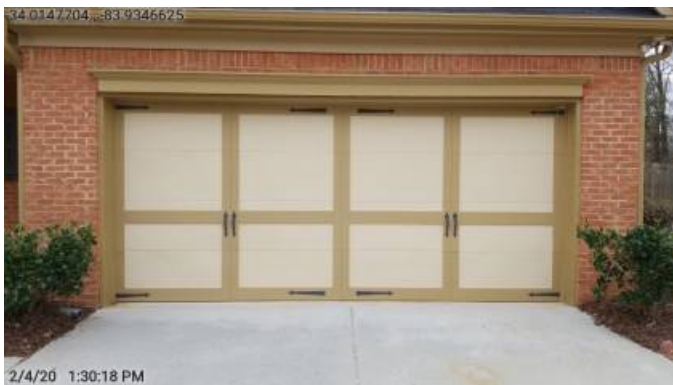
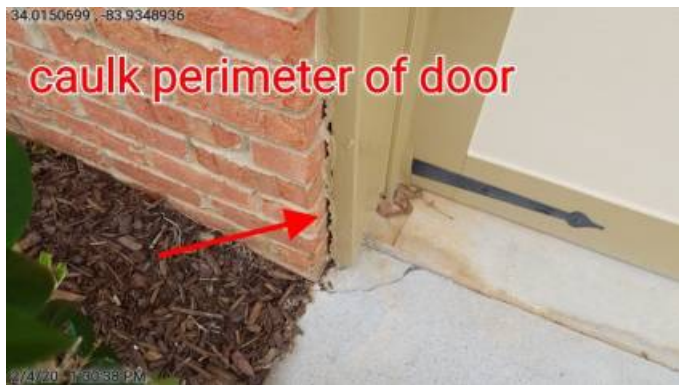
Missing or damaged caulk around the exterior door trim.  
 Recommend caulking the perimeter of the exterior doors to prevent water penetration.

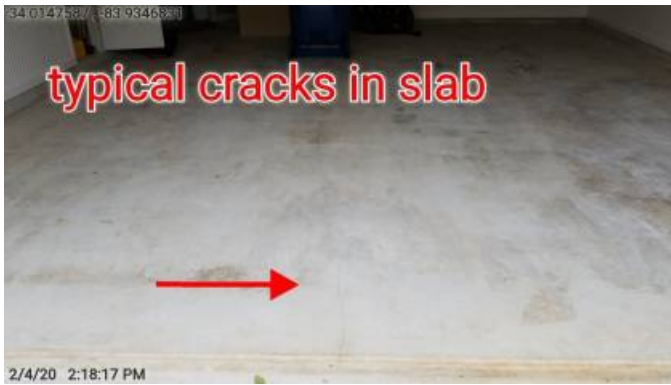
Typical cracks noted. Shrinkage cracks in all concrete is to be considered typical.
