**Report:** Sample home inspection 2020

# **Confidential Inspection Report**

**123 Sample Rd**  
**Dacula, GA 30019**

**February 4, 2020**

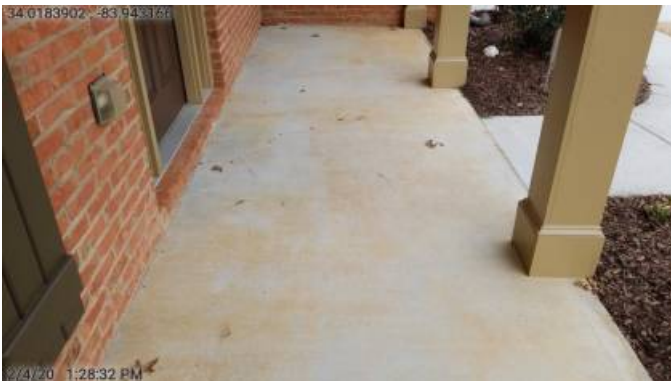
Deterioration noted at base of the posts. Recommend repairing / replacing the damaged sections of wood on the porch posts.

Cracks noted are typical. Typical cracks include normal shrinkage of the concrete. Recommend applying a sealant or seal all cracks to prolong service life of the porch.

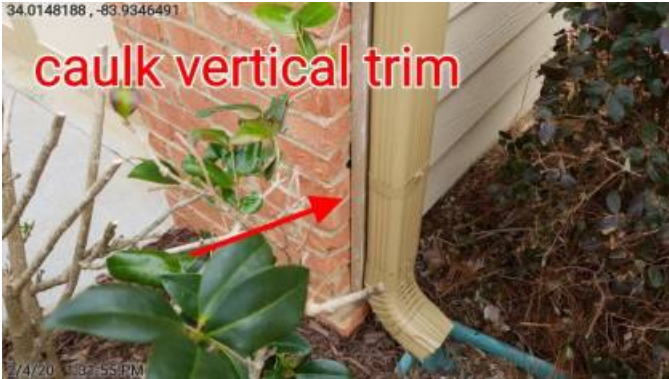
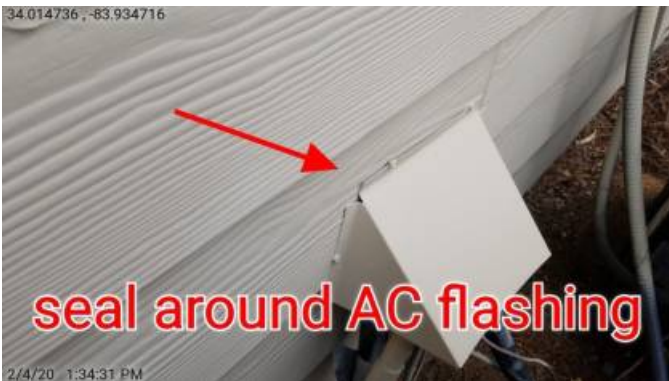
Water damaged trim was noted on one or more locations around the home. Recommend a licensed contractor repair / replace all affected trim on the home to help prevent water penetration behind the siding system.

Recommend sealing the flashing around the AC lines to prevent water penetration around the AC lines.

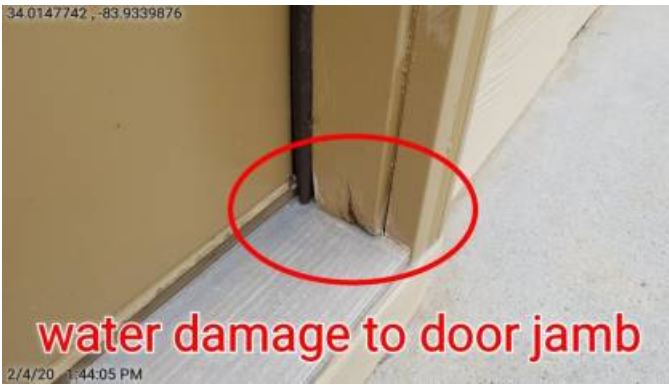
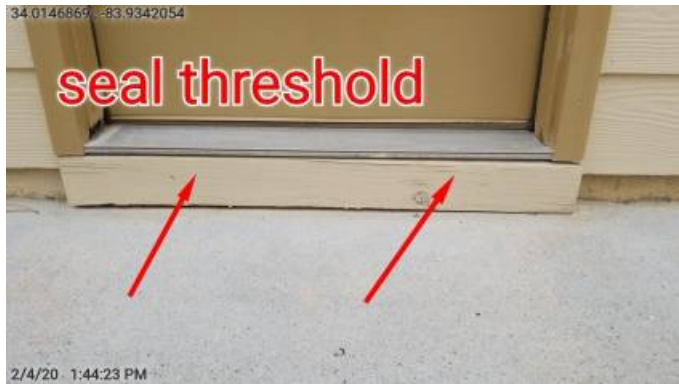
The threshold is not sealed at the base of the door. Seal / caulk the base of the front door to help prevent water penetration.

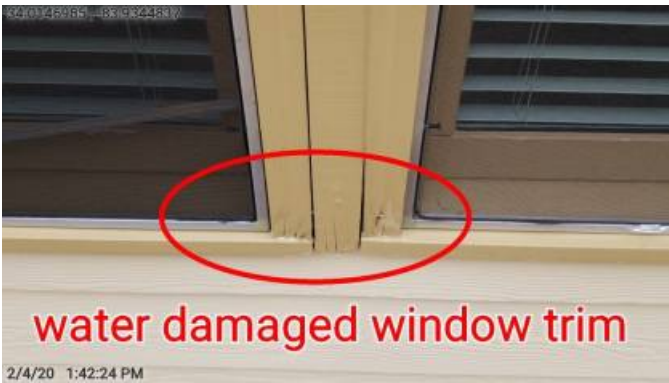
Water damage was noted on one or more window(s) around the home. Recommend a licensed contractor repair or replace all damaged sections of the windows and / or trim as necessary.

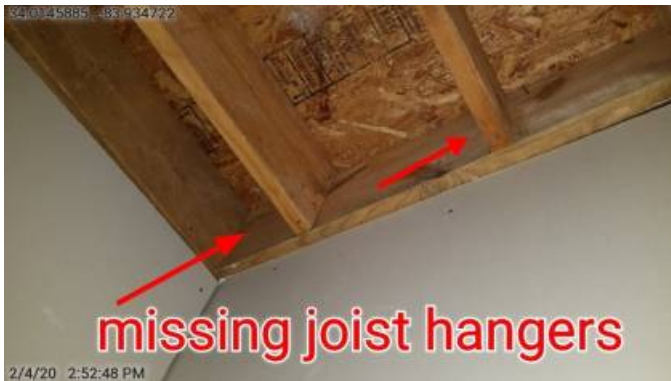
There are floor joists below the stair landing which were not correctly supported. Recommend installing joist hangers at all affected joists.

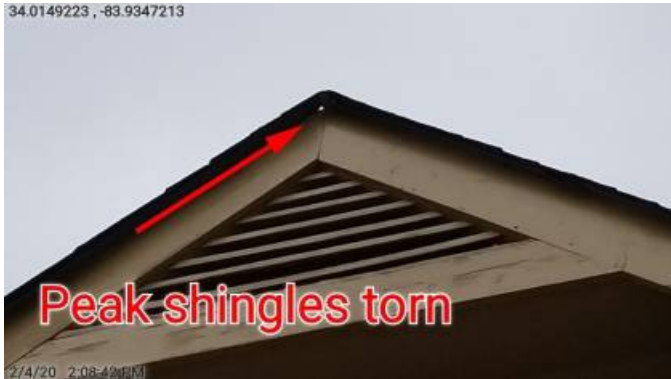
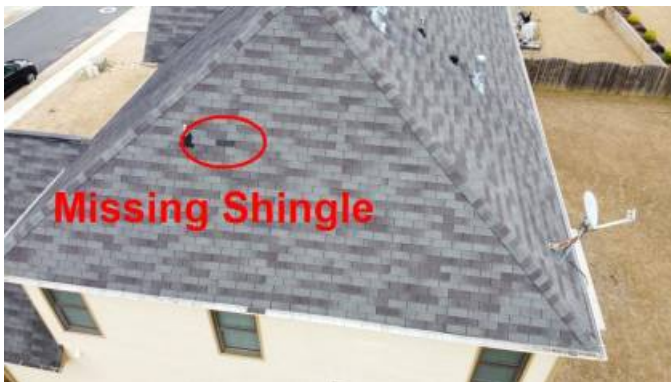
Roof is nearing the end of its normal life expectancy. Roof covering replacement is needed in the near future. A licensed roofing contractor should be called to make further evaluation and to provide cost estimates for roof covering replacement in the near future.

Cracking and clawing of shingles are the result of long term weathering and an advanced shingle age. Felts are showing through.

Several of the shingles are raised due to nails backing out of the sheathing. Recommend sinking all raised nails to ensure all shingles are flush with the roof.

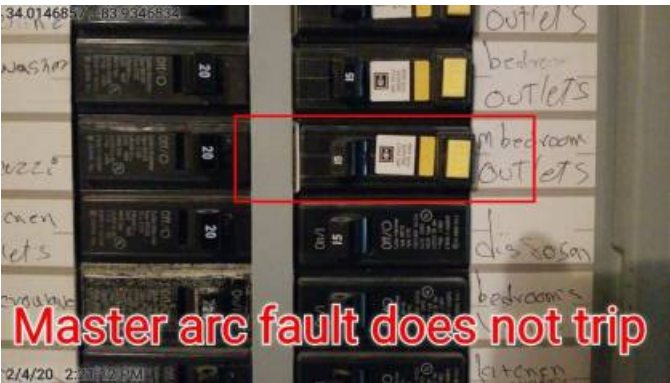
6.6 Main Panel Observations:      OK   MM   RR   IS  
            One or more of the Arc-Fault breakers in the panel did not trip when tested. Recommend a licensed electrician replace the defective Arc-Fault breakers.

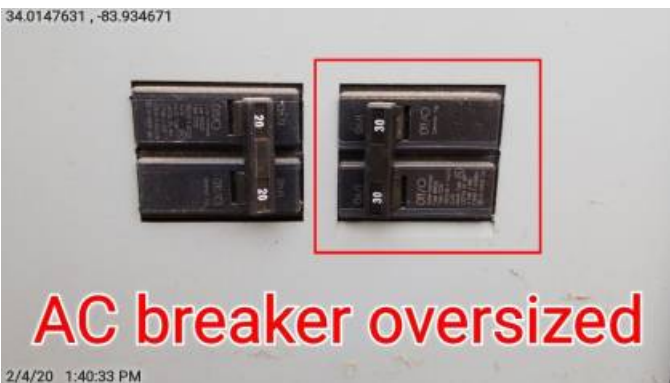
6.7 Sub Panel 1 Observations:                  Subpanels are located at the air conditioner.

There is a 30 amp breaker installed on an AC unit which is rated for a maximum of a 25 amp breaker. Recommend a certified electrician replace the current AC breaker with the appropriately sized breaker for the AC unit.

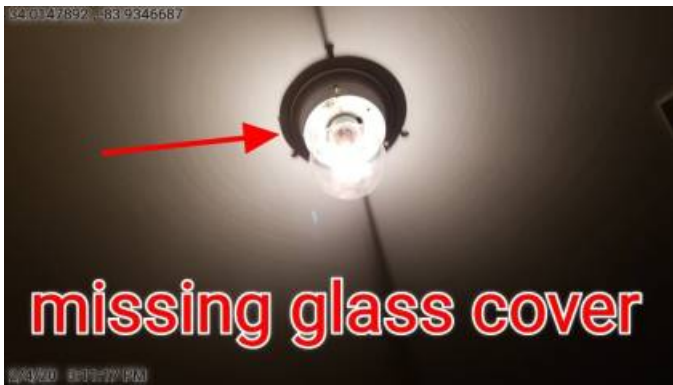
6.10 Kitchen Interiors:	<input checked="" type="checkbox"/>	<input type="checkbox"/>	<input type="checkbox"/>	<input type="checkbox"/>	
6.11 Master Bath:	<input checked="" type="checkbox"/>	<input type="checkbox"/>	<input type="checkbox"/>	<input type="checkbox"/>	
6.12 Second Floor Bath:	<input checked="" type="checkbox"/>	<input type="checkbox"/>	<input type="checkbox"/>	<input type="checkbox"/>	
6.13 1/2 Bath:	<input checked="" type="checkbox"/>	<input type="checkbox"/>	<input type="checkbox"/>	<input type="checkbox"/>	
6.14 Back Right Bedroom:	<input type="checkbox"/>	<input checked="" type="checkbox"/>	<input type="checkbox"/>	<input type="checkbox"/>	Missing the glass cover / globe on the light fixture in this room. Recommend replacing the missing cover.

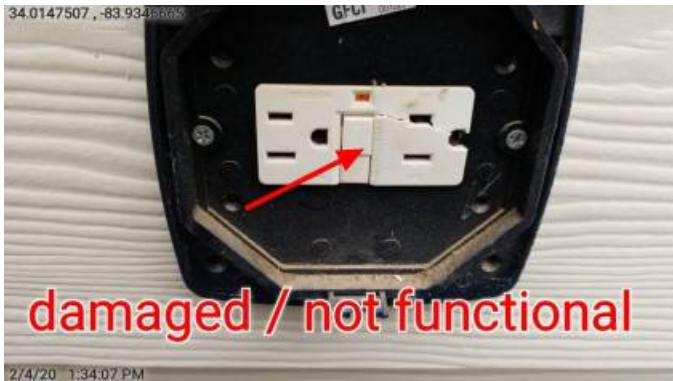
6.16 Exterior Walls:	<input type="checkbox"/>	<input type="checkbox"/>	<input checked="" type="checkbox"/>	<input type="checkbox"/>	One or more loose / damaged outlets were noted on the exterior of the home behind the AC unit. Recommend a licensed electrician replace the affected outlets.
----------------------	--------------------------	--------------------------	-------------------------------------	--------------------------	---

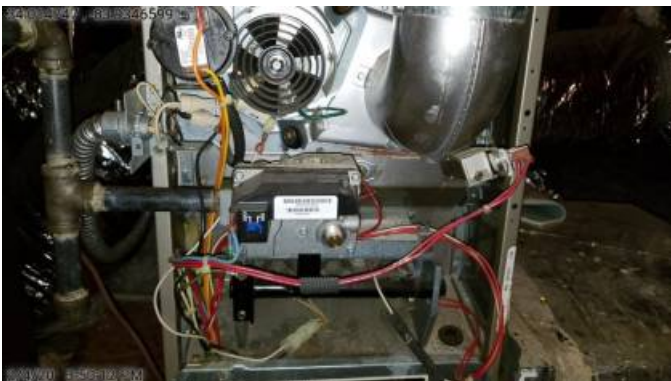
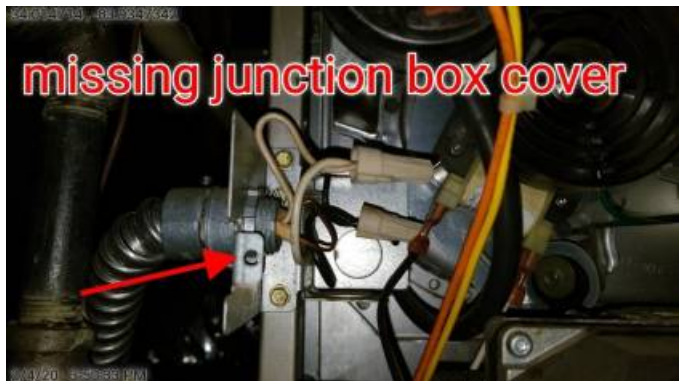
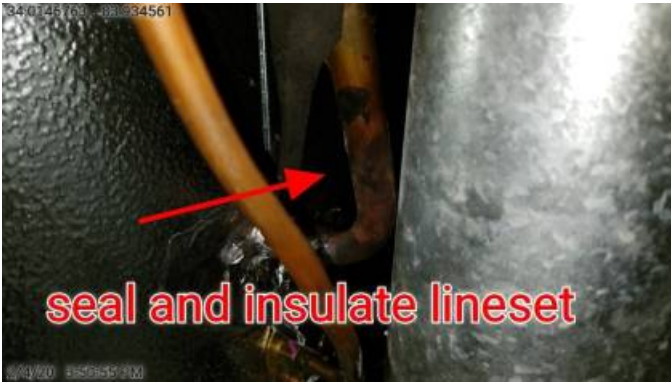
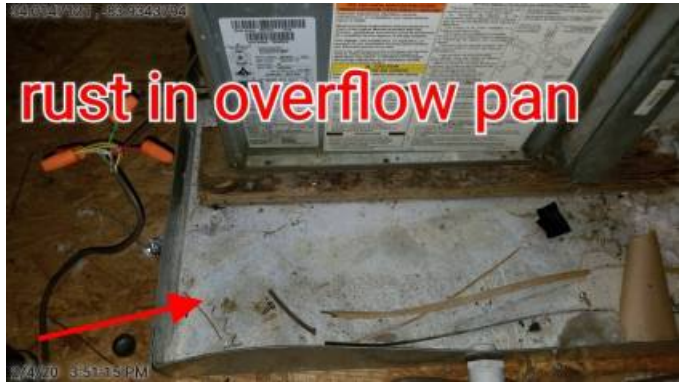
The insulation on the refrigerant lines and at the hole in the cabinet to the unit is damaged and / or missing. This is causing condensation to drip into or around the burner compartment below and air leak from the cabinet. Recommend repairing the insulation up to the evaporator coil cabinet and sealing the penetrations in the cabinet.

Rust / water staining was noted in the condensation pan at the time of the inspection. This is an indication of a previous condensation back up or problem with the evaporator coil. Dry at the time of the inspection. Recommend inquiring with the current homeowners as to the cause of the rust and repairs made. Recommend an HVAC technician service the unit and verify proper operation of the unit.

Missing the junction box and / or junction box cover located inside the burner compartment. All wire splices should be enclosed in an appropriate junction box. Recommend repairs by a licensed electrician.

Suggest cleaning / servicing burner compartment, blower motor, evaporator coil, pilot light, vent system and burners. Clear / service all condensation lines. Additionally, we recommend cleaning the duct work for improved indoor air quality.

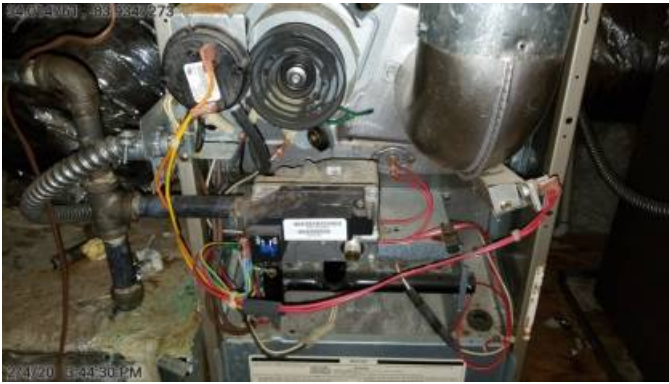
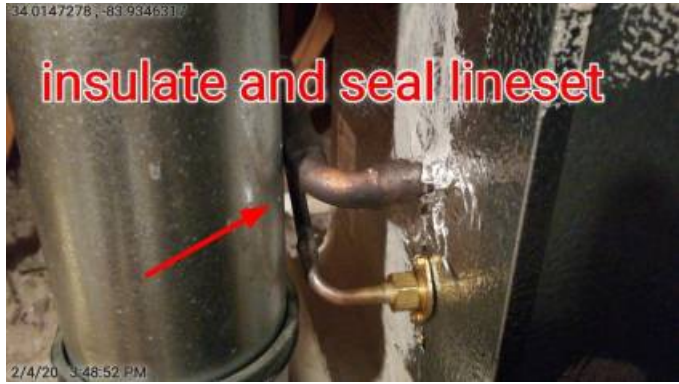
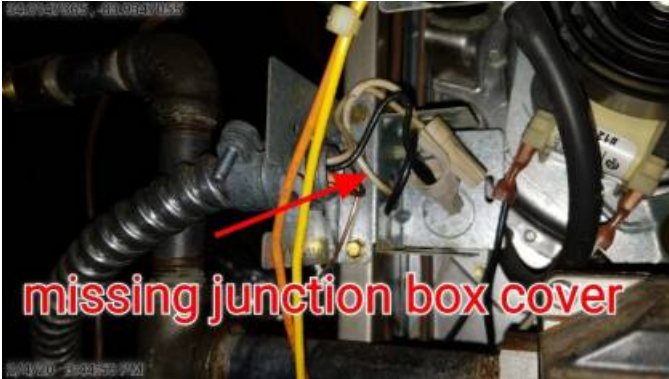
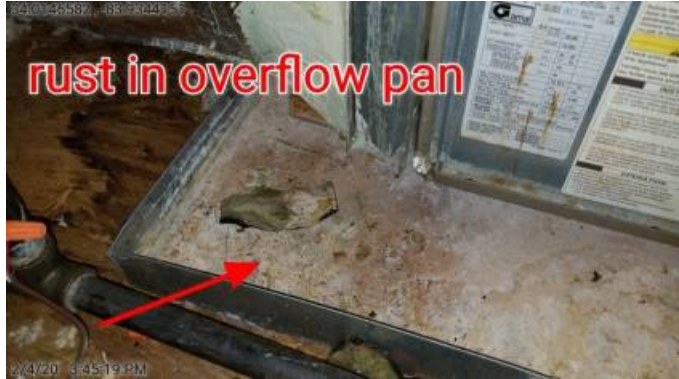
7.26 General Operation & Cabinet:  OK  MM  RR  IS The insulation on the refrigerant lines and at the hole in the cabinet to the unit is damaged and / or missing. This is causing condensation to drip into or around the burner compartment below and air leak from the cabinet. Recommend repairing the insulation up to the evaporator coil cabinet and sealing the penetrations in the cabinet.

Missing the junction box and / or junction box cover located inside the burner compartment. All wire splices should be enclosed in an appropriate junction box. Recommend repairs by a licensed electrician.

Suggest cleaning / servicing burner compartment, blower motor, evaporator coil, pilot light, vent system and burners. Clear /

service all condensation lines. Additionally, we recommend cleaning the duct work for improved indoor air quality.

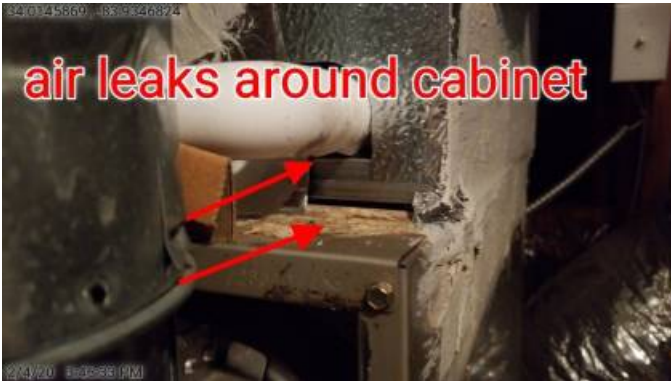
| 7.30 Flues, Vents, Plenum: | <input type="checkbox"/> | <input checked="" type="checkbox"/> | <input type="checkbox"/> | <input type="checkbox"/> |

Air leaks were noted on the plenum in the form of deteriorated tape or some other opening in the plenum. Recommend an HVAC technician seal the plenum for improved efficiencies on the system.

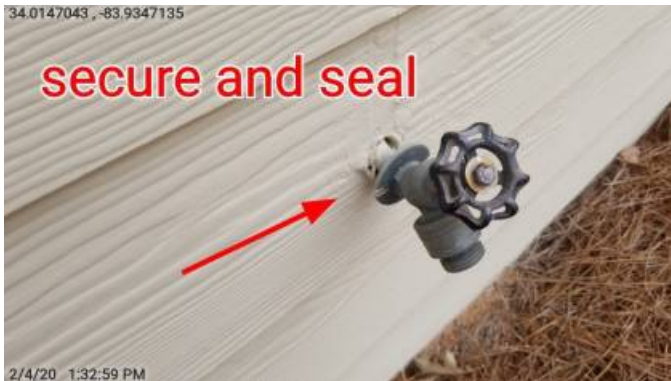
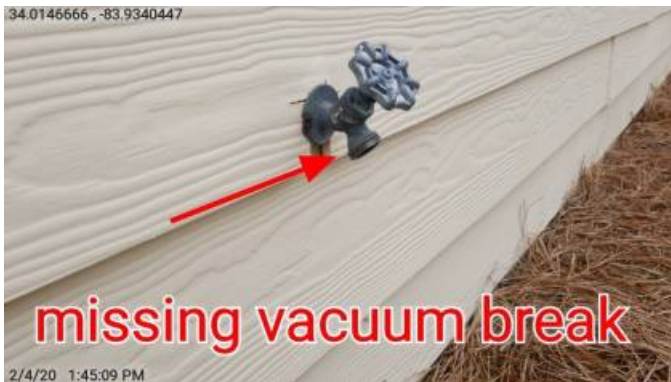
8.9 General:     Leaks noted at or around the valve stem on one or more exterior faucets. Recommend repairs by a licensed plumber.

One or more of the exterior faucets are loose. Recommend securing the faucet to the siding.

There is at least one hose bib missing the vacuum break (backflow device).

There are gaps noted around one or more of the water faucets around the exterior of the home. Recommend securing and sealing the faucet to the wall to prevent water penetration behind the siding system.

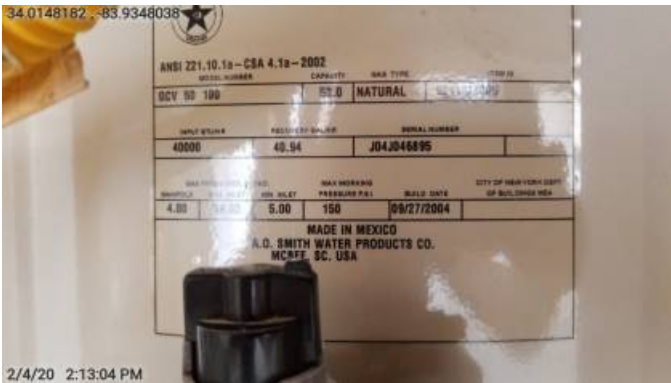
Manufactured In: 2004

The average life span of a tank water heater is 15 years. The unit is beyond it's design life. Replacement should be anticipated in the near future.

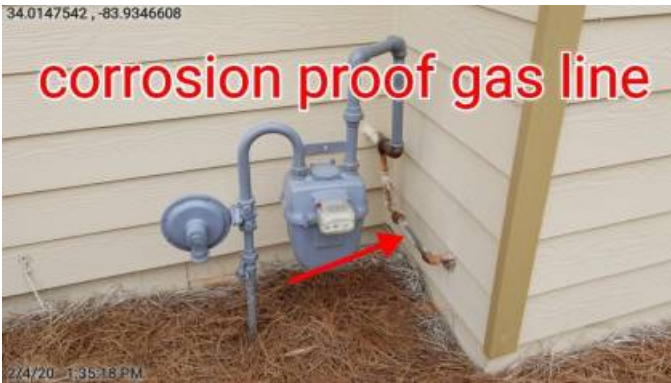
Meter is located at the exterior of the home, at the side of the house.

Portions of the gas line between the gas meter and the homes wall are not corrosion proofed. Recommend corrosion proofing the gas lines to prevent further rusting.

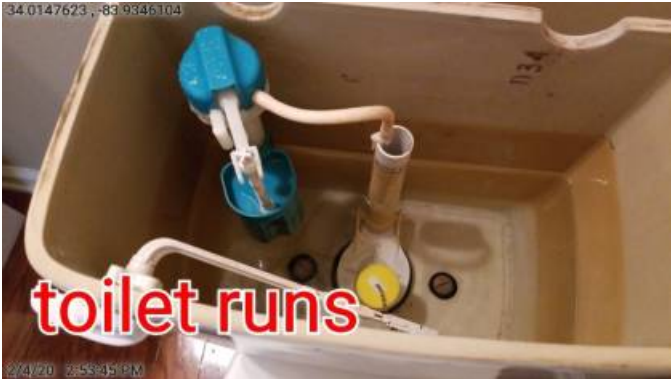
10.6 1/2 Bath:

Toilet runs on after being flushed- The rubber flapper at the tank bottom and / or fill valve requires replacement or repairs.

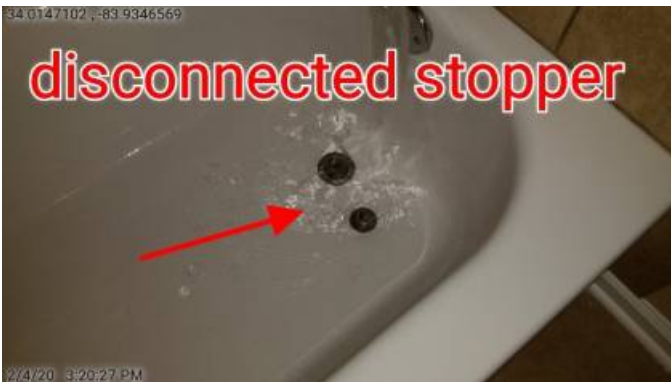
10.8 Second Floor Bath:

The stopper in the tub has been disconnected. Recommend re-installing the stopper for proper operation.

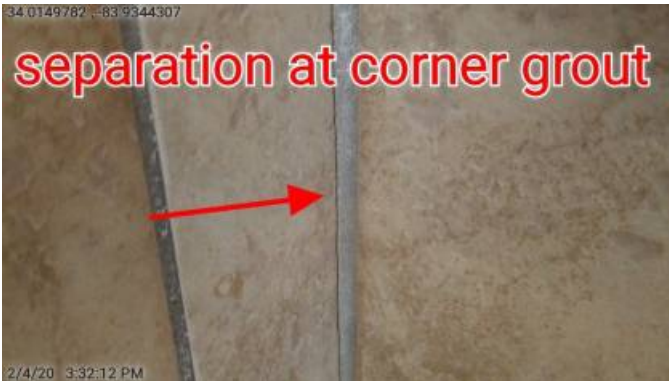
10.9 Master Bath:                     OK    MM    RR    IS    Tile

The grout in the corners of the shower is deteriorating. Recommend repairs / re-grouting to the corner.

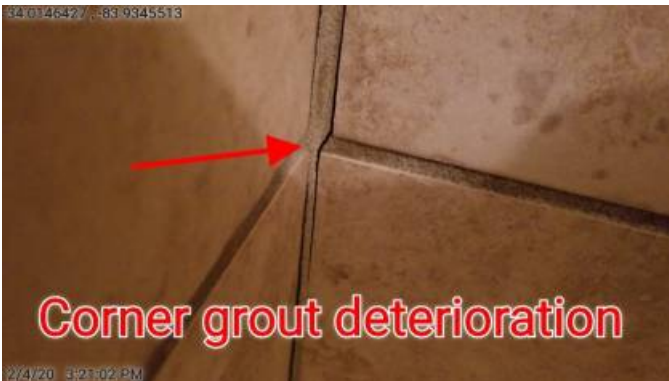
10.10 Second Floor Bath:            OK    MM    RR    IS

The grout in the corners of the shower is deteriorating. Recommend repairs / re-grouting to the corner.

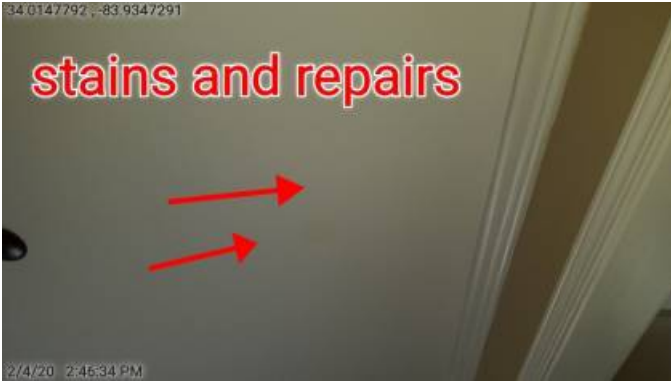
11.3 Kitchen Interiors:	<input type="checkbox"/>	<input type="checkbox"/>	<input type="checkbox"/>	<input checked="" type="checkbox"/>	Previous Leak - There are signs (stains or repair) of a previous water leak or damage to the ceiling in this room. Stains appear to be dry at the time of the inspection. Monitor condition as sheetrock can dry if plumbing fixtures have not been used in the recent history or if it has not rained in recent history making an active leak difficult or impossible to identify. Recommend
-------------------------	--------------------------	--------------------------	--------------------------	-------------------------------------	---

inquiring with the current homeowners as to any previous repairs made and any warranties that may transfer to the new owners.

Repairs noted to the ceiling in this room. Recommend inquiring with the current homeowners as to the nature of the repairs and monitor condition.

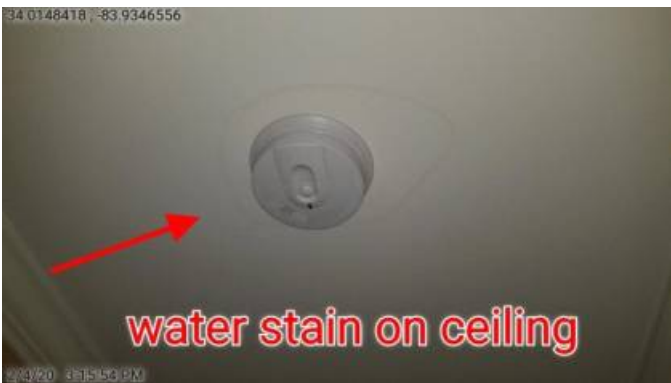
11.4 Entry / Foyer / Hall:

There are water stains in the ceiling that show evidence of an active water leak. The location would indicate water penetration or origination at the roof or flashing above. Please see the roofing section for details on the leak. Recommend painting the ceiling after repairs to the roof and ceiling have been made.

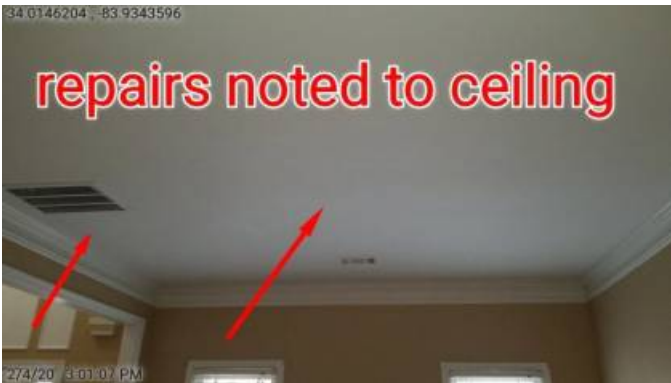
11.5 Formal Living Room:

Repairs noted to the ceiling in this room. Recommend inquiring with the current homeowners as to the nature of the repairs and monitor condition.

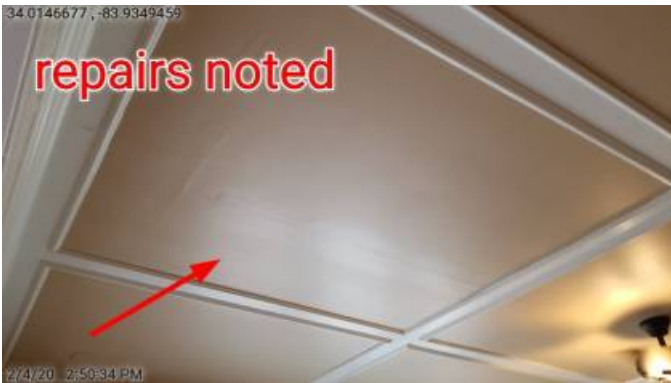
11.6 Family Room:

Repairs noted to the ceiling in this room. Recommend inquiring with the current homeowners as to the nature of the repairs and monitor condition.

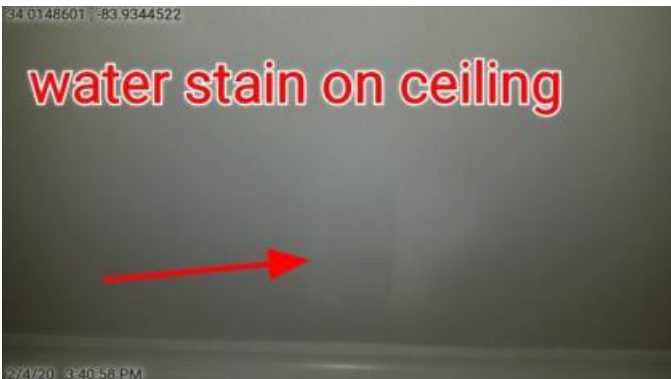
11.7 Master Bedroom:

Water stains were noted in this area. Obvious repairs were not noted to the roof or flashing above or to any plumbing fixtures. Based on the location of the water stains there may be a leak at the roof / flashing or a plumbing fixture above. Recommend inquiring with the current homeowner as to any repairs made. If no repairs can be confirmed, further evaluation and repairs by a licensed roofing contractor or plumber may be necessary.

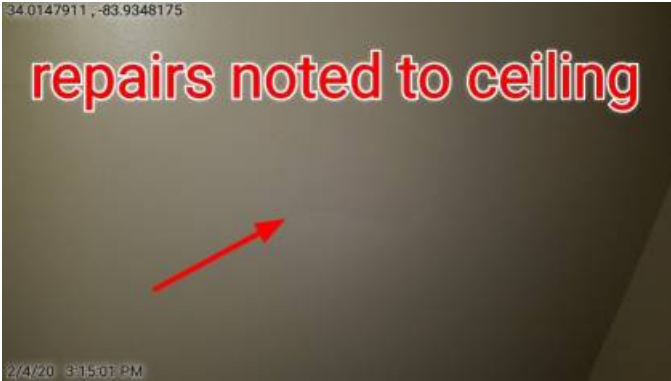
11.8 *Front Right Bedroom:*      OK   MM   RR   IS

Repairs noted to the ceiling in this room. Recommend inquiring with the current homeowners as to the nature of the repairs and monitor condition.

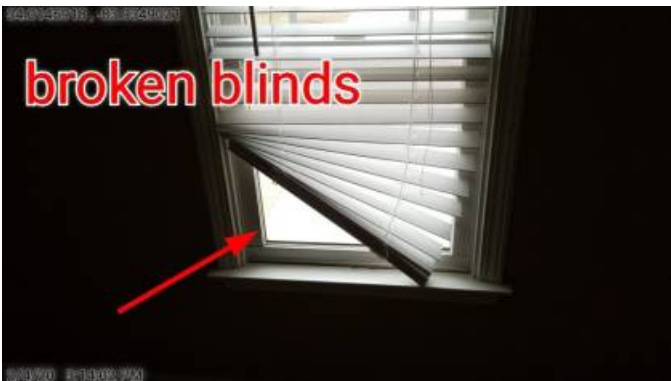
11.12 Front Right Bedroom:

One or more of the blinds are damaged in the room. Recommend replacing and are repairing the damage blinds.

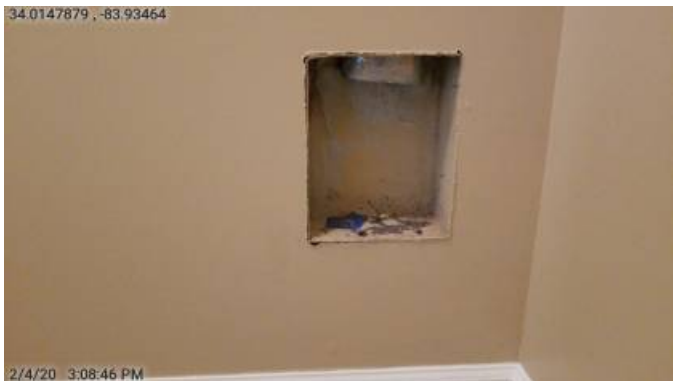
12.6 Dryer Vent:     A dryer vent is provided to the exterior of the home.

The dryer is venting to the roof. Recommend cleaning the dryer vent on a regular basis due to the uphill climb on the dryer vent.

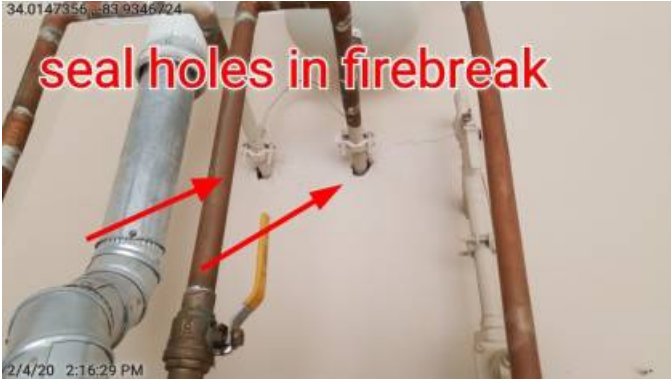
13.5 Garage Fire Rated Materials:  OK  MM  RR  IS

**Walls-** Damage or holes were noted in one or more locations in the fire wall separating the garage from the main home. Recommend repairing any openings with approved materials to restore its fire rating.

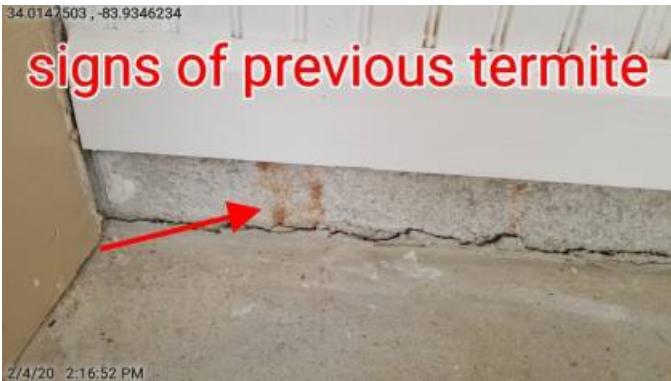
13.6 Pests:

There are signs of previous termite tunnels on the back garage wall at the concrete level. Recommend further evaluation by a licensed pest control company and inquire with the current homeowners as to any previous treatments for termites.
